Urban Lake Shoreland Restoration: Landform, Vegetation, and Management Assessment 20 Years Later

William Bartodziej and Susan Galatowitsch

Ecological Restoration Vol. 42, No. 2, 2024

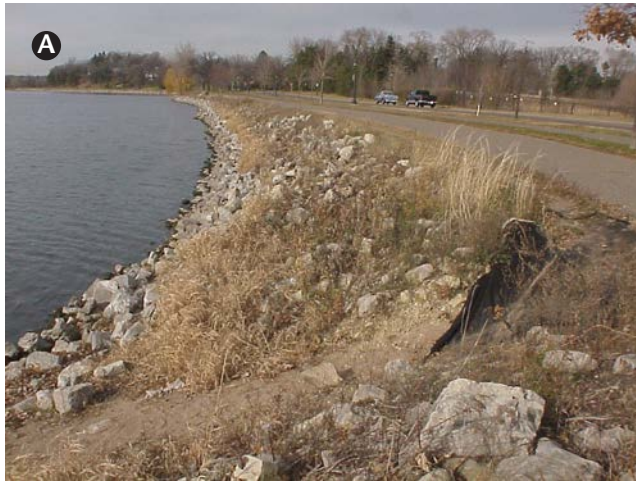
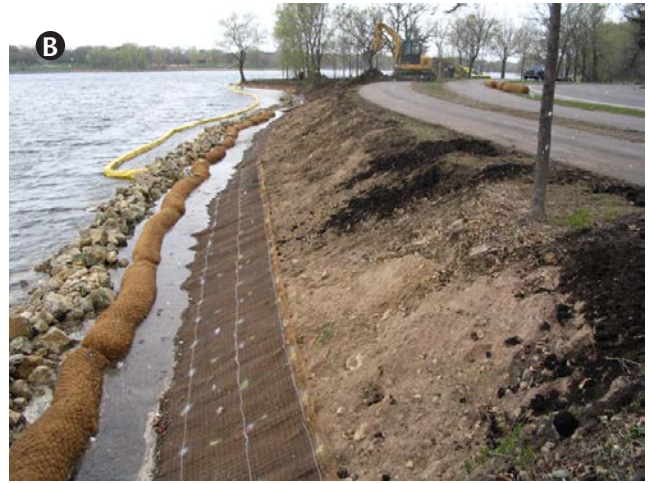
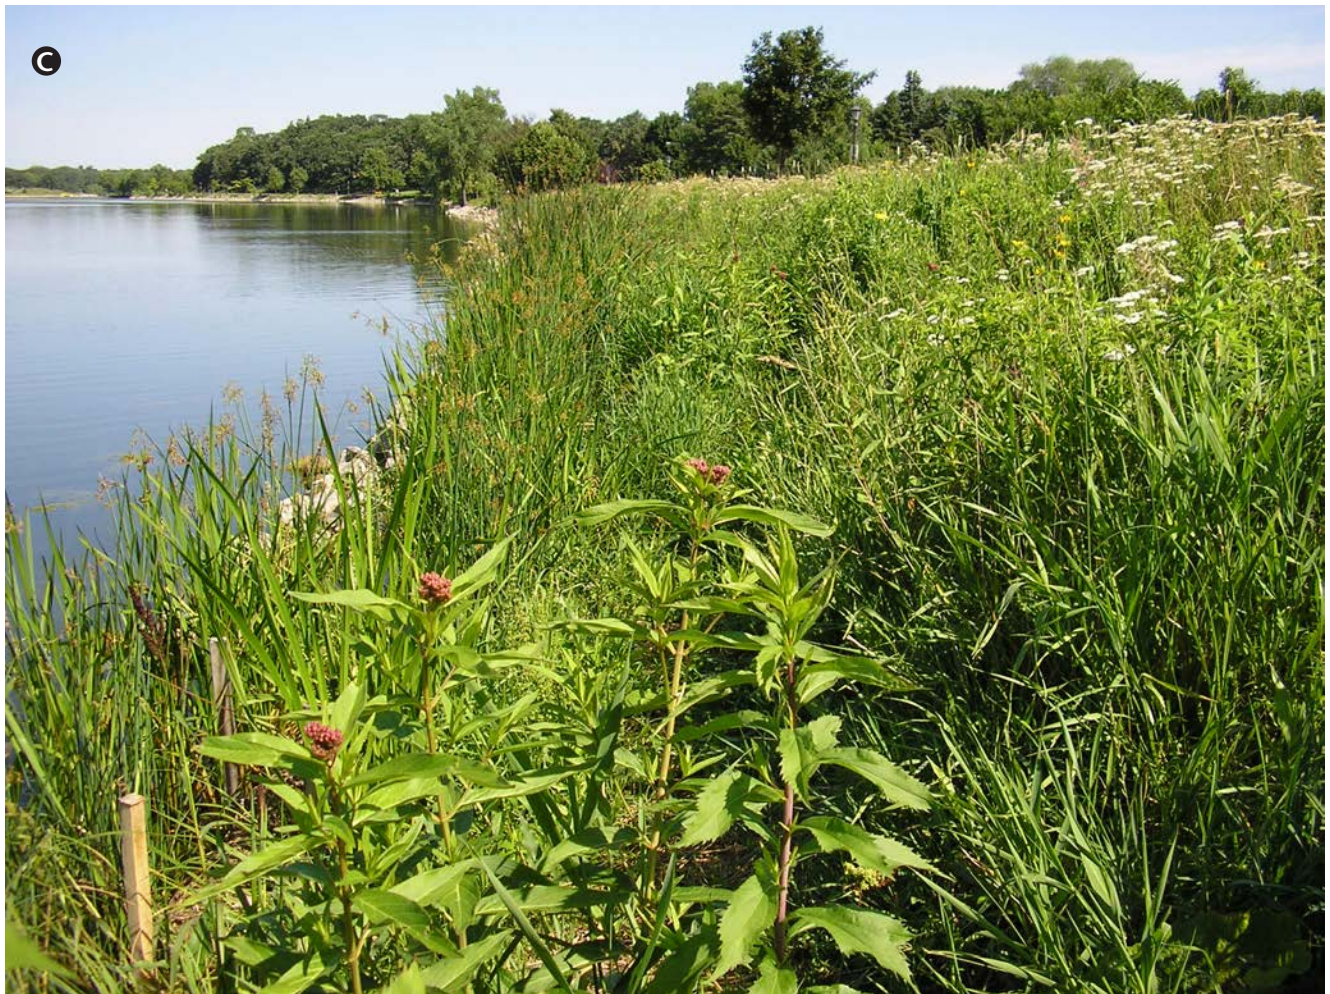
Figure 2. Pre-restoration, construction, and post-installation (6 yrs) comparison of Site H. A) Pre-restoration image shows the steep riprapped slope with an informal path (foreground) from a walking path to the water. A portion of the riprap was re-used to make an offshore wave-break. B) A biolog providing secondary wave protection. The bank was regraded, seeded and protected with North American Green S-75BN (upland) and C-350 (toe of the slope) erosion control blankets. Emergent, wet meadow and upland prairie zones established by the sixth year (post-construction). C) Emergent vegetation (primarily *Schoenoplectus tabernaemontani*; softstem bulrush) colonized and spread between the offshore rock berm and the OHW elevation.

that provide the main offshore wave protection (i.e., biologs were installed as secondary protection, Table 3, Figure 2). The total distance of bank erosion was 302 m (11% of total restored shoreline) with 60% of the bank erosion length occurring on one site (C, along an area of shore without berm protection). For all restoration sites, buffer width loss was equal to or less than 30 cm, which is within the error limits of the photo interpretation. Informal footpaths formed on all the restored shorelines and are responsible for all bare soil areas greater than 1 m². These paths were heavily used, had an average width of 50 cm and extended from paved park pathways to the water's edge. Forty-one of the 50 footpaths occurred on four sites (B, C, G, H).
